*Office of Oversight
Independent Technical Review of*

The West Valley Demonstration Project Event

April 1997

Office of Environment, Safety and Health

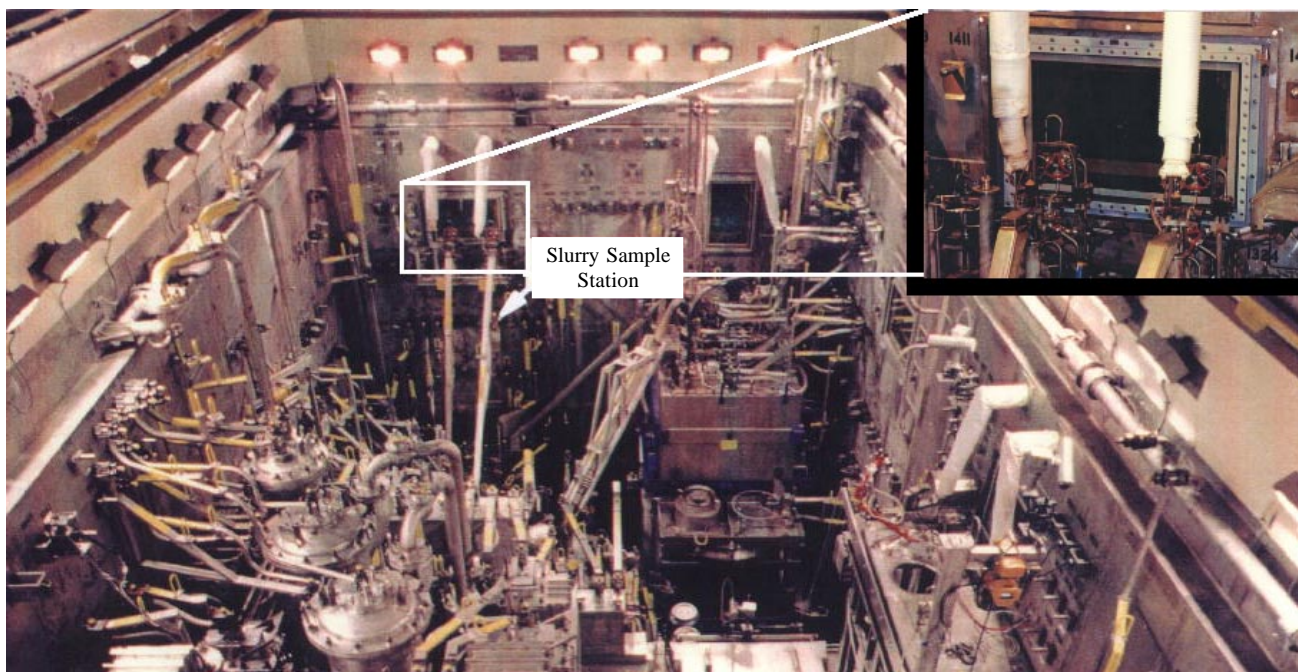
A view of the sample station from inside the vitrification cell. The inset shows the manipulators and window where operators draw the samples. The CFMT sampler is on the right.

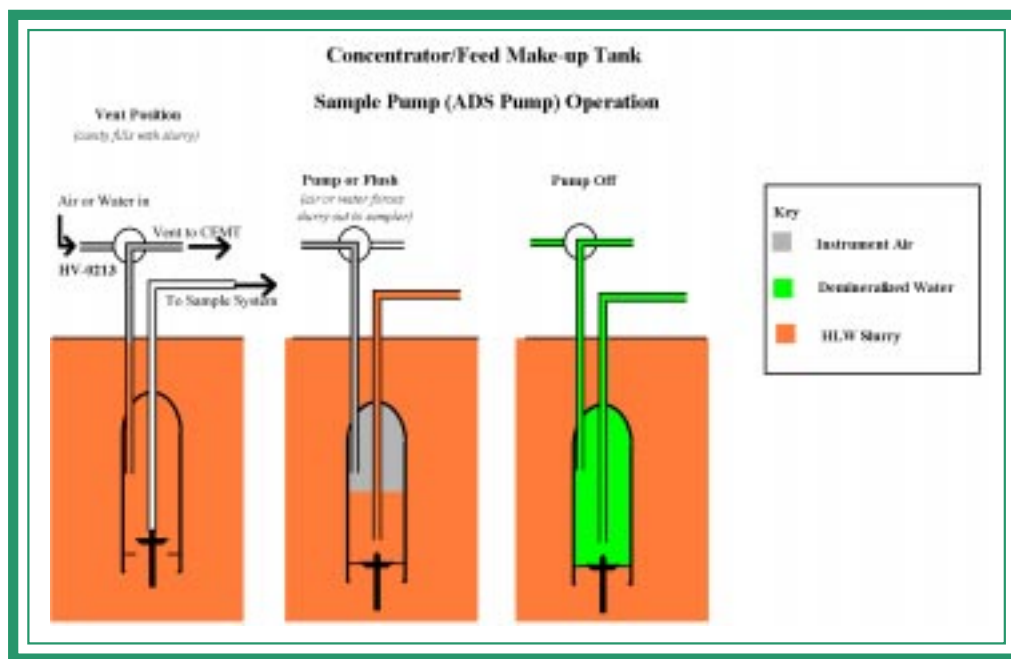
After a preset time (nominally 20 seconds), HV-0213 rotates to allow instrument air (nominally 35 psig) to push the slurry out of the chamber and into the sample system. HV-0213 and the poppet then cycle in sequence every 20 seconds to provide slurry flow through the sample station back to the tank. When the pump is turned off, HV-0213 allows water to flush the pump and sample system for 30 seconds and then returns to the vent position, leaving the pump filled with water. The sample system consists

the chamber into the sample system. A simplified diagram is provided above. Valve HV-0213 is normally in the vent-to-CFMT position. When the chamber is opened to the tank, the slurry displaces the air or water in the chamber, filling the chamber.

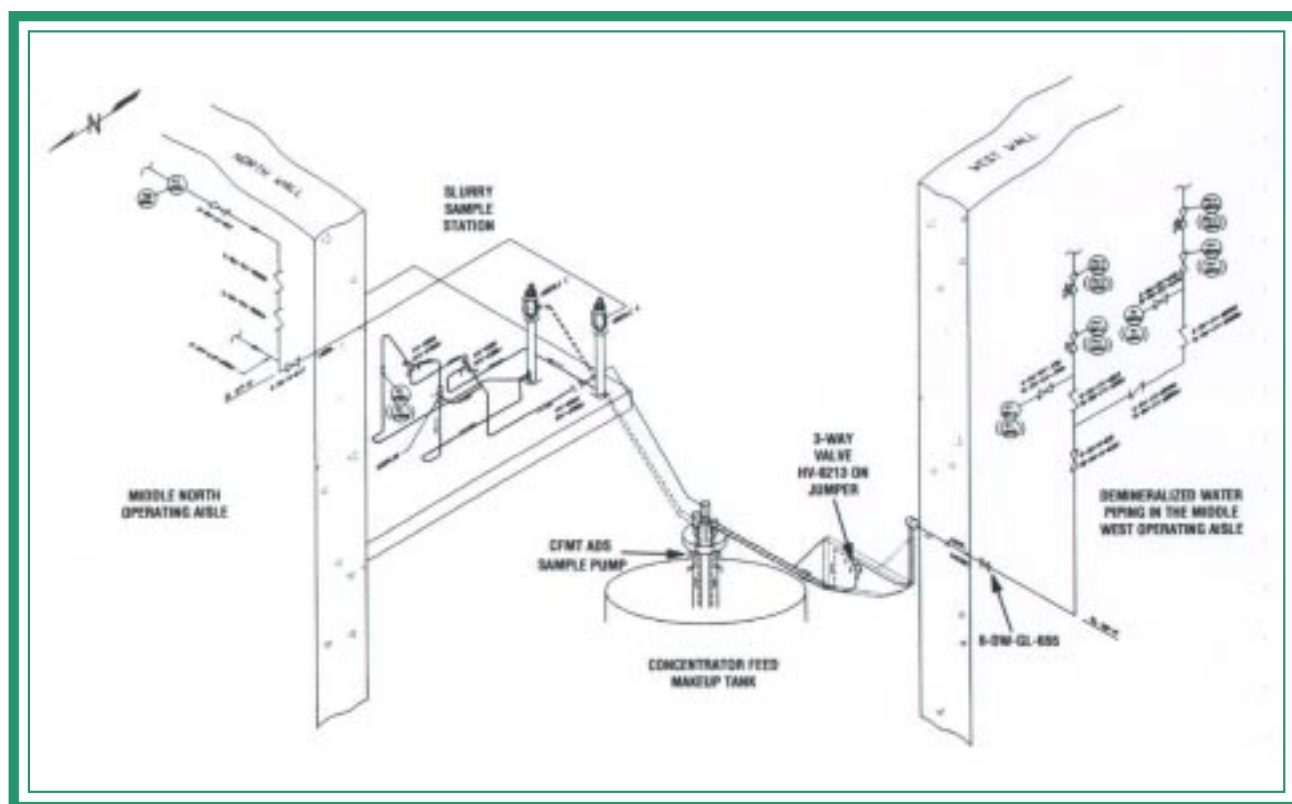
**Simplified Schematic Showing Layout in the Vitrification Cell
of the Slurry Sample Piping, the Sample Pump, and the Demineralized Water Piping**

The flushing operation was carried out based on instructions that were handwritten on a system drawing. The instructions stated, “After regular flushing with ADS sample pump off, then place both 3 ways in B-C position and flush for 30 sec into CFMT.” The lineup for the flushing operation was not reviewed by anyone not immediately involved with the flushing. The Shift Engineer had concerns regarding the status of the sampling pump, but raised them only after the event occurred. Other technical personnel indicated that there was no reason to perform the flush in the manner in which it was conducted.

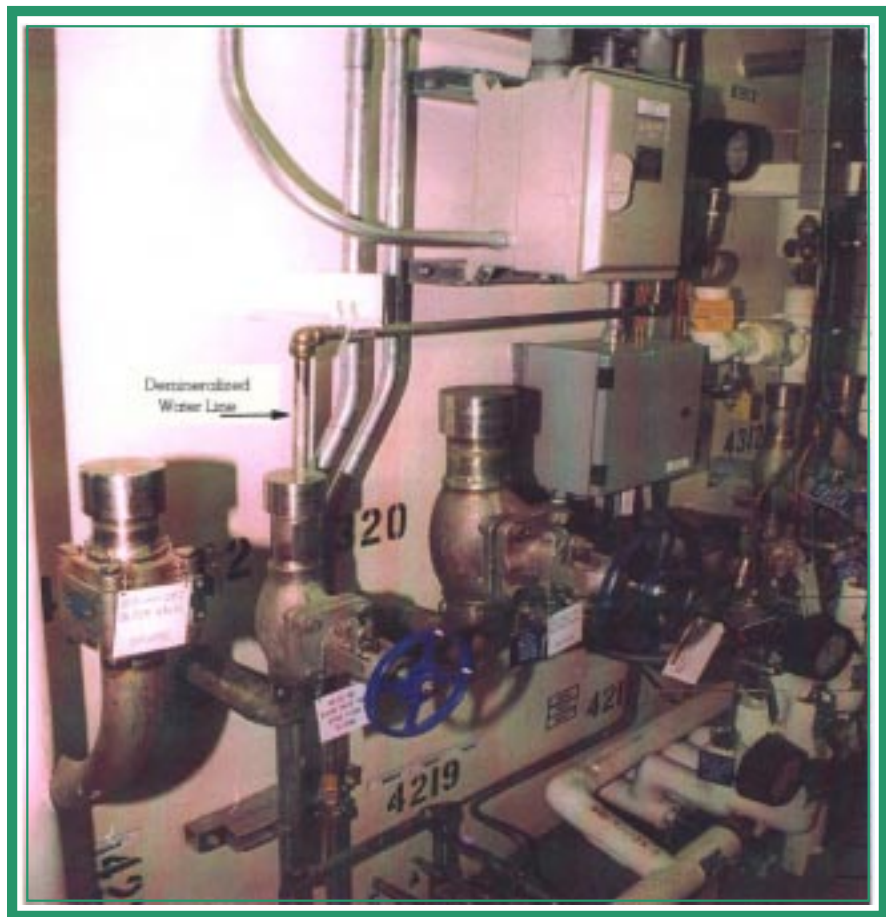
The radioactivity content of the liquid was approximately 7 millicuries per cubic centimeter of Ba-137m. Post-event investigations concluded this was about half the highest possible concentration of radioactivity. Both the initial slug of radioactivity and residual holdup had the effect of raising ambient radiation levels in the control room and operating aisles where another radiation monitor alarmed. In

Demineralized Water Line in the Operating Aisle where Slurry Was Flushed out of the Cell

- The contact radiation levels at the demineralized-water line outside the cell were probably much higher than the 3.1 R/hr reflected in the occurrence report. WVNS calculations indicate that the peak level may have been closer to 20 R/hr and could have been over 40 R/hr under different conditions.

The pipe holding the backflushed material was flushed and shielded to reduce the contact dose rate.

An ion chamber was placed next to the pipe prior to the flushing operation such that the RCT could read the instrument while remaining in a low dose rate location. The material was eventually flushed back into the cell, reducing the contact dose rate from 3.1 R/hr to between 40 and 50 mR/hr. However, several radiation monitors and air monitors were still alarming from the high area background. It was then decided that lead blankets should be hung over the pipes as temporary shielding. This further reduced the contact dose rate on the pipe to 7 mR/hr. At that point, the RCTs began to document the event and the measurements made during the recovery phase.
